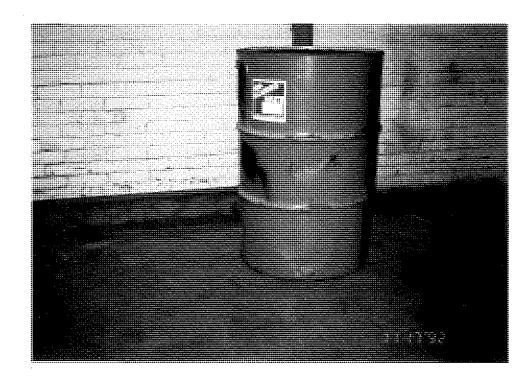
Photograph No. 2 Orientation: West

Description: Container Staging Area

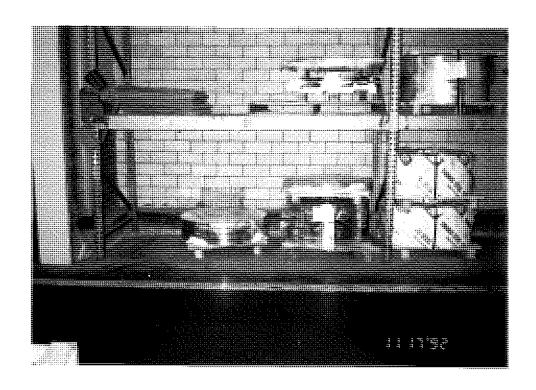
Photograph No. 3
Orientation: West

Description: Former Container Storage Area currently used to store raw materials

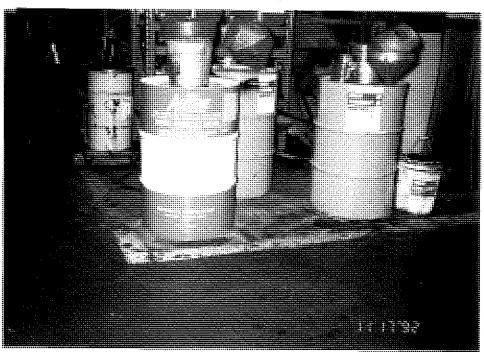
Photograph No. 4 Orientation: Southwest

Description: Waste Collection Area

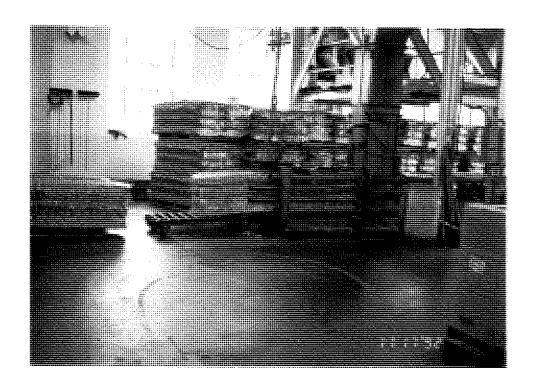
Photograph No. 5 Orientation: East

Description: Scrap Aluminum Accumulation Area

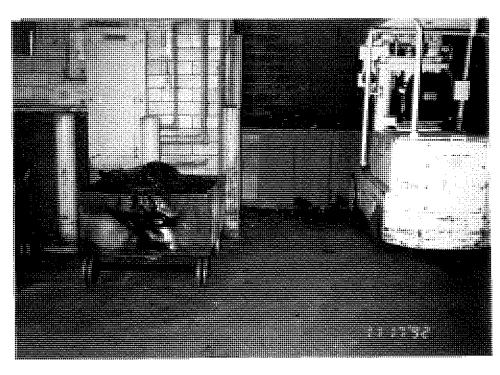
Photograph No. 6 Orientation: South

Description: Scrap Glass Accumulation Area

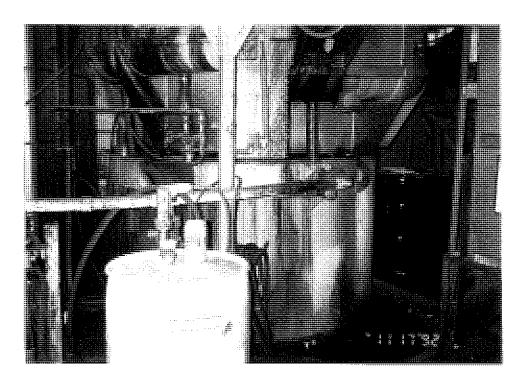
Photograph No. 7 Orientation: East Location: SWMU 7
Date: 11/17/92

Burnishing Sludge Accumulation Area; burnishing system sludge is collected in the

black steel drum

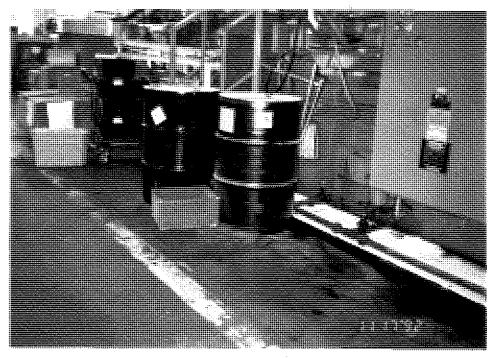
Photograph No. 8

Description: Perchloric Sludge Accumulation Area; perchloric sludge is collected in the drum on the right; the drum on the left contains product

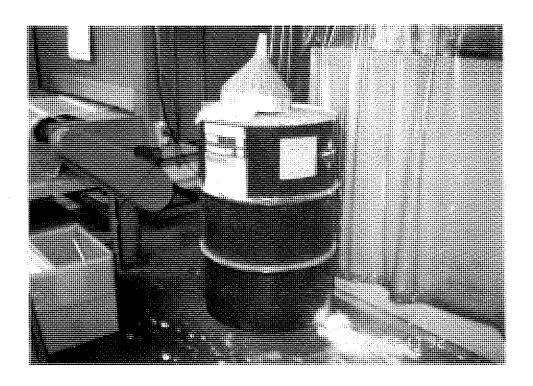
Photograph No. 9 Orientation: Southwest Location: SWMU 9 Date: 11/17/92

Description: Waste Paint Accumulation Area; small amounts of paint have stained the floor in

this area

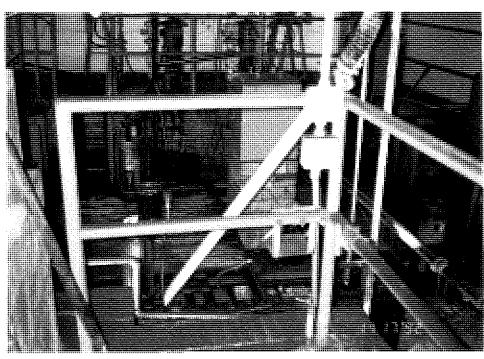
Photograph No. 10 Orientation: North

Description: Wastewater Treatment System

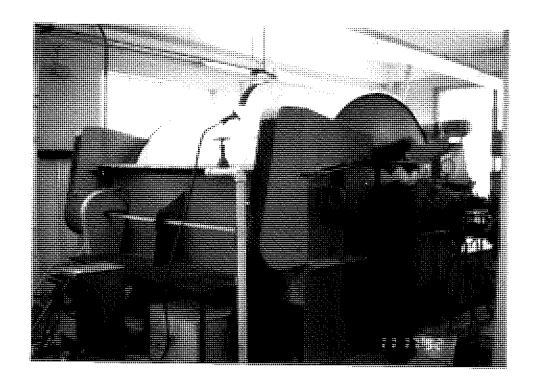
Photograph No. 11

Orientation: Southwest
Description: Filter drum of the Wastewater Treatment System
